AUSTIN 7 ENGINE – TORQUE SETTINGS (lbf./ ft.)

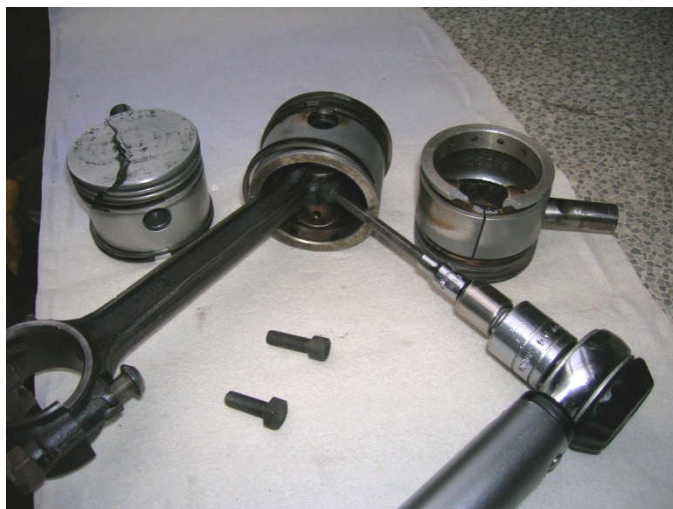
Blown-up, yes, but that is another story. So what are the pictures all about? My Torque List started with 'Little-end Allen screws' and I have been asked to elaborate on the use of them and why – so here goes.

Soon after I got 'Pearl' a horrible rattle came from the engine, but lasted no more than 5 seconds or so but she ran fine all the way to the New Brighton Rally and back home. Investigation showed a piston to be shattered (on the left) and this had been caused by a little-end screw shearing off and getting trapped between the piston and con-rod as it fought it's way down to the sump. Ouch! The piston on the right is from another engine, but this time it only knocked a couple of pieces off the bottom of the skirt. Apart from the damage to the pistons, one rod was bent and in both cases the gudgeon pin had moved in the piston and rod, carving nice 'tram-lines' in the cylinder bore.

Why had the screws sheared?

1. They were not high-tensile and nor were the ones supplied by one of our main suppliers! Yes, they were black, but not HT.

2. Had they been over tightened?
Who knows – but probably. You can't get a socket and torque wrench on them so it is all down to 'feel'. Too tight and the result is as above. Too slack and the gudgeon pin is not clamped sufficiently to stop it 'fretting' in the con-rod eye.

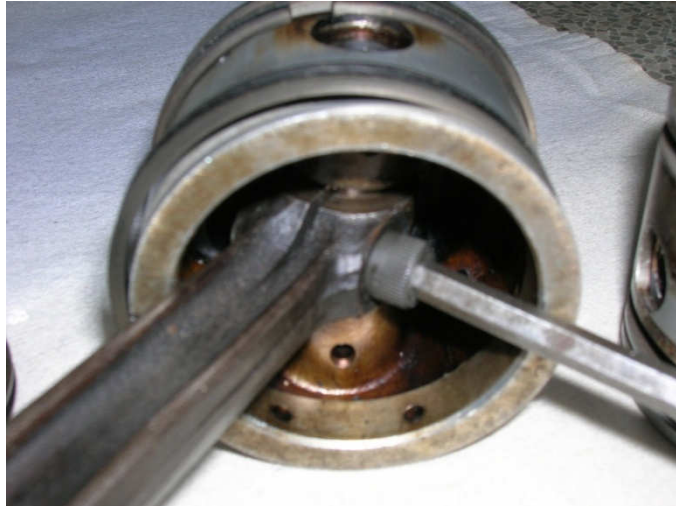
This is what got me thinking that there had to be a better way and Unbrako Allen screws were the answer.

They are HT (very) and by choosing a 'cap head' I could use a straight Allen-key to get outside the skirt and apply my torque wrench via a series of adaptors.

The picture above shows the general principle and the other is a close-up of the screw and Allen key in place. I hope the above will give you 'food for thought', but I stress that this is my opinion only – perhaps there are those amongst you who decry any variation on the 'original'?
